HOME BUYERS INSPECTION SERVICE

INSPECTION FOR: Lucia Sunset LLC, c/o Ann Miranda, Proportunity, 650-630-6068

INSPECTION OF: 1443 25th Ave, San Francisco, CA

Property inspected is a three story multi-level dwelling with wood siding and stucco over wood frame with raised wood and concrete slab floors. Roll and shingle composition roofs. Lot is near level. Garage is built-in below at right front.

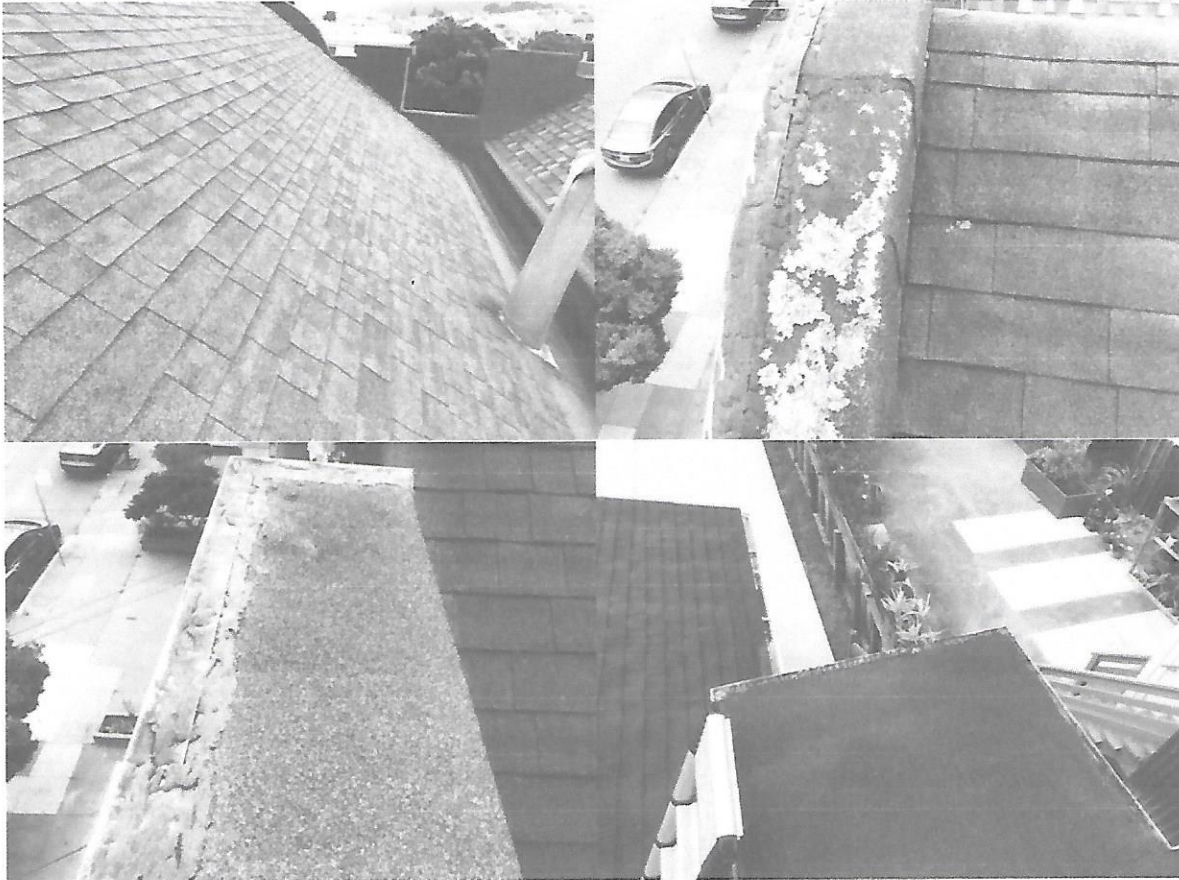
Main roof: Laminate type composition shingles appear to have general wear. Mineral surface is worn off in most areas. Overall roof life appears to be approx. 70-80% used. Sealant around vent pipes is worn. Water tightness is not warranted. Drain scuppers at the left and right rear need minor repairs to guide water into scuppers.

1. Main roof has some moderate wear. See also 1.1.

Coated roof at front appears generally sound. Gutter at front has loose joint. Recommend maintenance. Recommend roofing contractor be contacted for repairs or estimate.

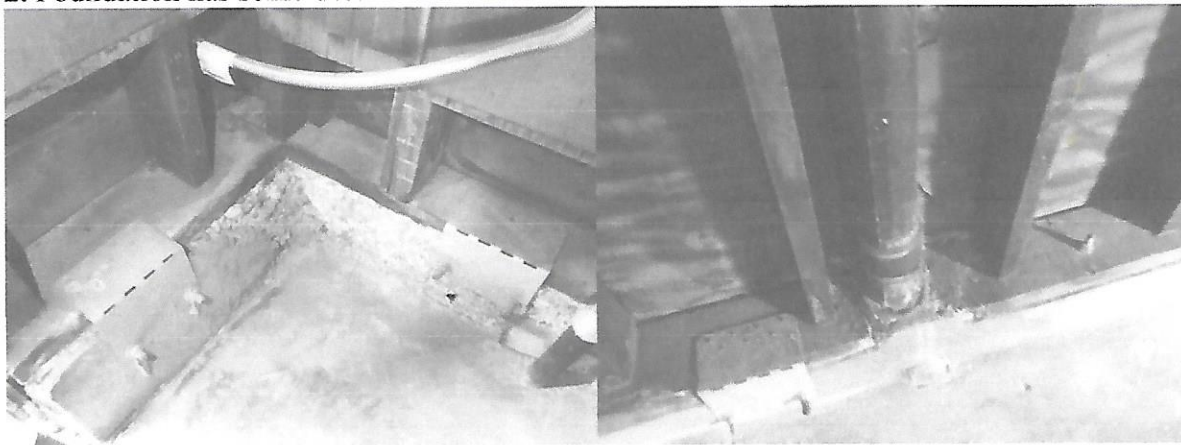
Perimeter type foundation is partially visible in the garage area and has some cement coated areas. A few areas of original foundation show evidence of moisture deterioration and crumbling.

2. Foundation has some deterioration. See 1.8C

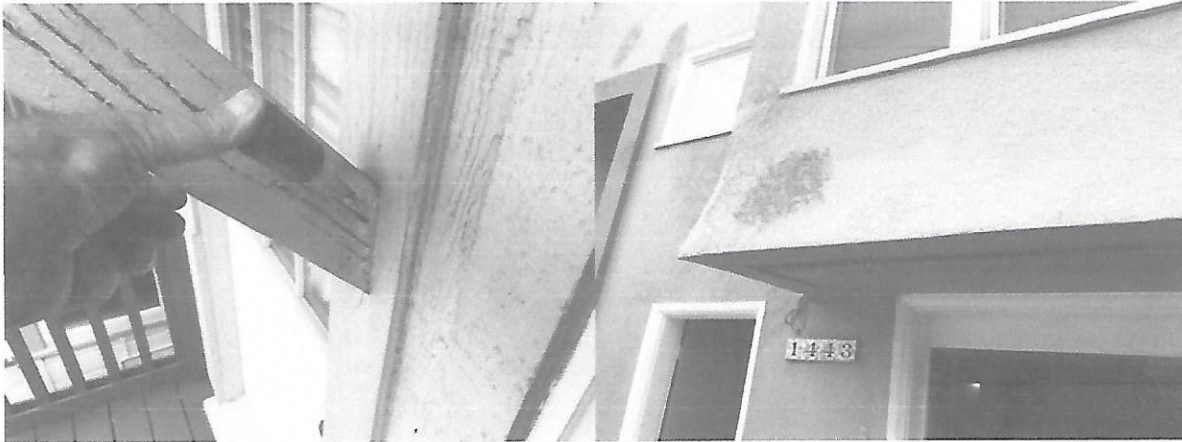
Wood trim and exterior wood has some weathering and cracked and peeling paint.

Lap siding has some newer paint over scraped older paint and some rough surfaces. Several areas have worn or cracked paint. Trim has several cracked paint areas. Recommend maintenance and eventual repainting following repairs to some deteriorated wood trim and metal drip edges.

3. Siding, exterior wood and paint has some weathering. Recommend pest inspection. Stucco has some texture variation.

Recommend maintenance. Recommend pest inspection.

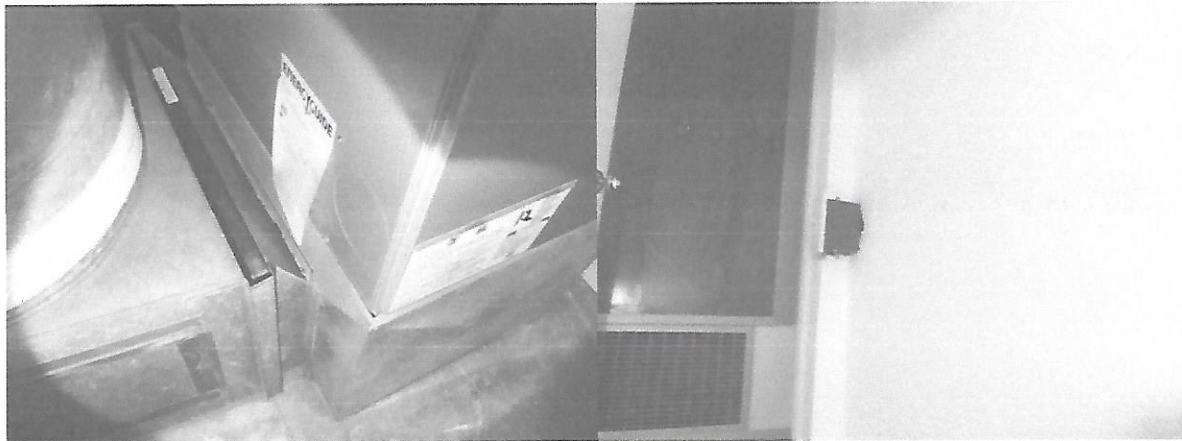
Furnace cold air return filter cap cover was not installed and dust is in the cold air return.

Paper wrapping on heat ducts and furnace may contain asbestos, not uncommon.

4. Furnace maintenance recommendations. See 2.3.

Recommend a furnace contractor be contacted for thorough and maintenance repairs and evaluation for safety and proper operation. Recommend PG&E be contacted to turn gas on and for routine evaluation.

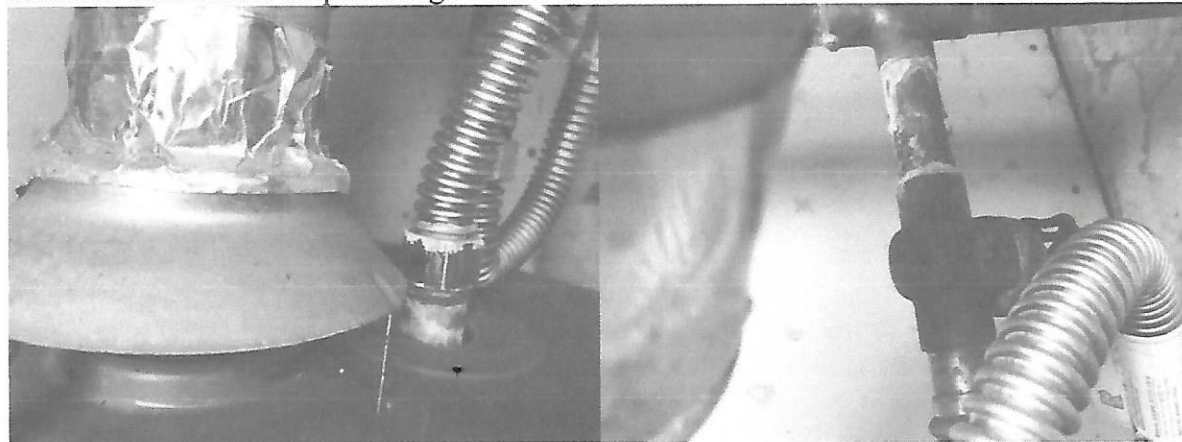
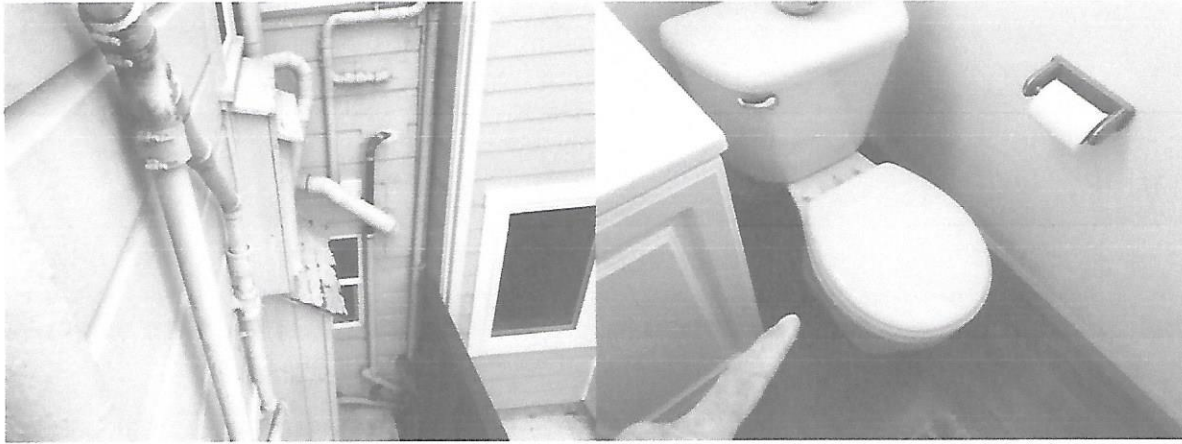
Waste lines are galvanized and cast iron. Corrosion is noted to some visible piping.

Toilets are slightly loose, recommend reset or secure.

5. Minor corrosion is on plumbing. Toilets are not secured. See 2.2.

(Underground pipe condition is not determined.) Recommend minor repairs and maintenance.

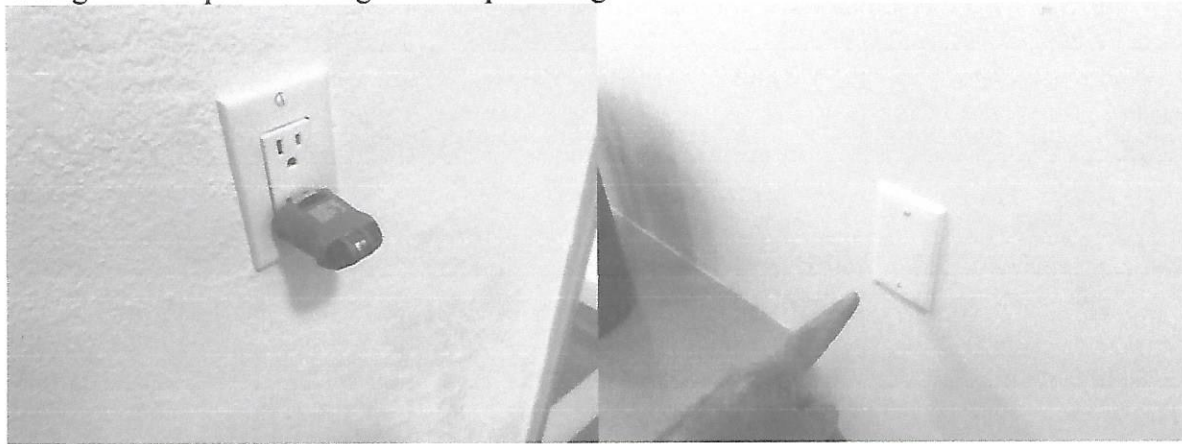
Three prong receptacles are installed. Several three prong receptacles (ground type) are not grounded in original house areas and this is probably due to original knob and tube wiring in the attic and structure. One switch box is plastic type. Wiring behind furnace area is touching piping. Recommend electrician be contacted for evaluation and minor repairs as needed for safety.

6. Some upgrading to the electrical is noted. Modifications are also noted. Range hood in addition wiring is incomplete. Wiring touches plumbing near furnace. See also 2.1.

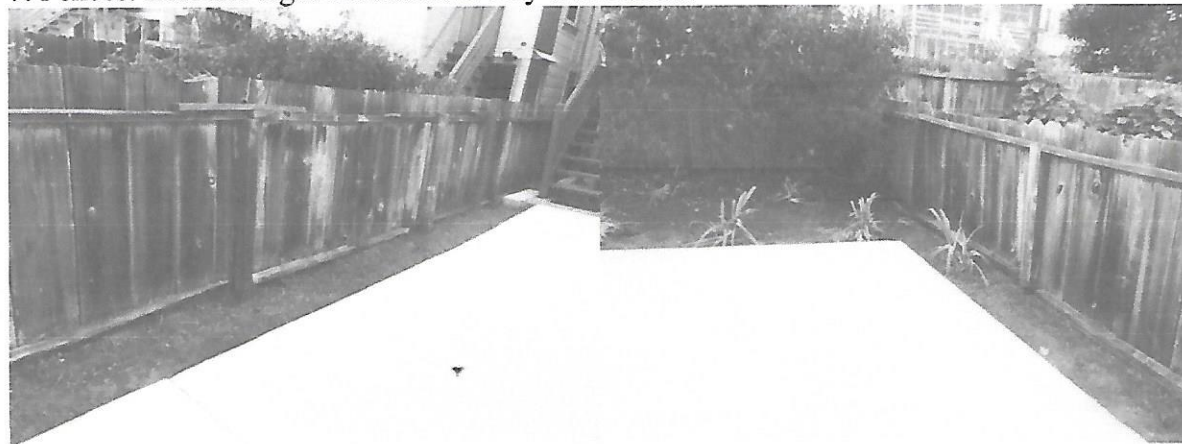
7. Fences: Left and right fences have very worn areas.
